# **Project Report for the Avocational Archaeological Survey of the Railroad Car Ferry Number 2 (Indiana Site 12La0642)**

**Submitted in Partial Fulfillment of the Qualifications for NAS II Certification**

**Underwater Archaeological Society of Chicago**

**February 2016**

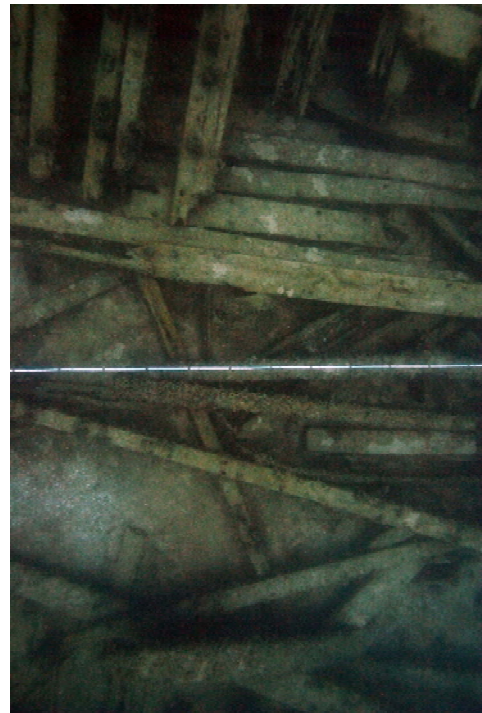
**Figure 18 - Photo Typical of the Bow.**

The main wreck site is quite large, measuring 330 ft long and as wide as 100 ft in parts. The centerline lies at 350 degrees with the bow at the north end. The bow area is broken and scattered, as shown in Figure 17 and Figure 18:

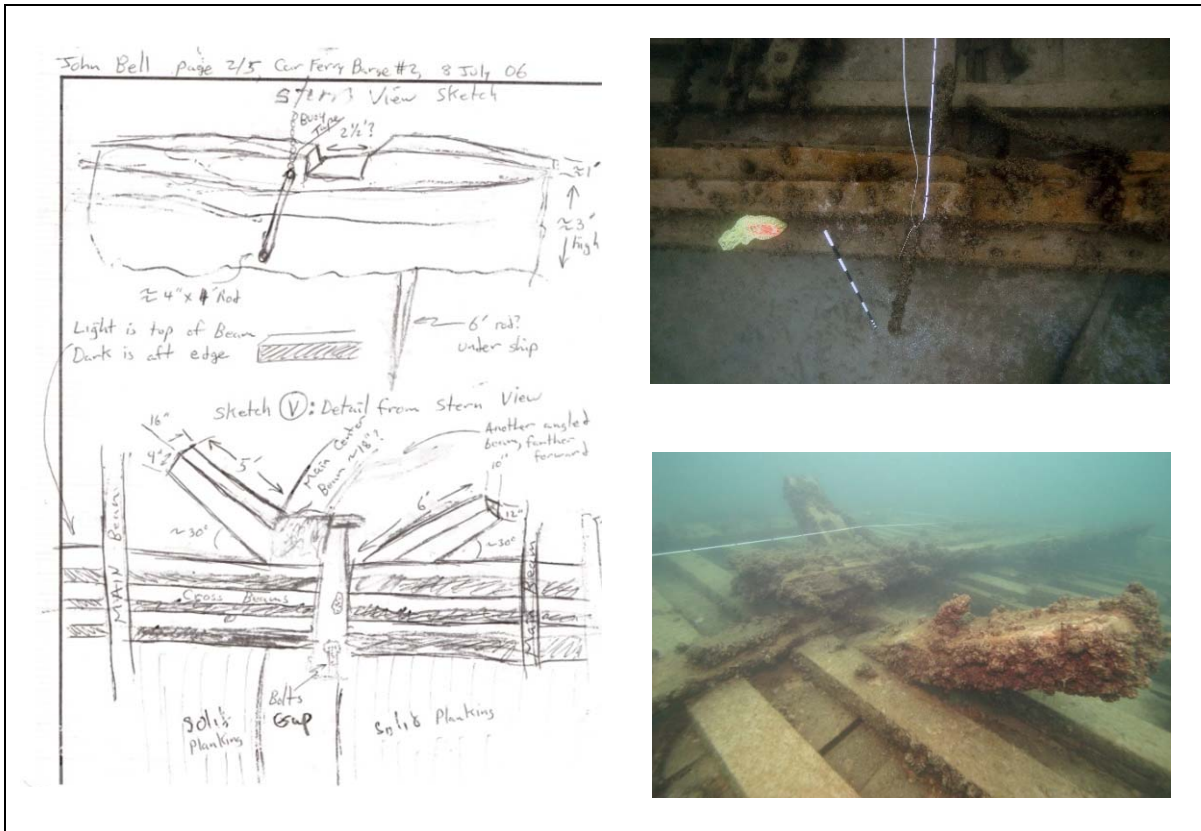
**Figure 19 - Sketch and Photos of Stern and "V-Brace"**

Moving forward (north) there are 2 large beams measuring 10 x 10 in forming a “V” rising approximately 30 degrees from the deck beams. The right hand beam is 6 ft long and is 16 ft from the transom. The beam comprising the left side of the “V” is 5 ft long and is 18 ft, 9 in from the transom. Keeping in mind, we were looking at the wreck from below the car deck, these two beams formed an inverted “V” supporting the car deck at the center. On the starboard side of the transom, the hull pieces are detached from the main deck. Running forward, the hull pieces join the main deck wreckage 52 ft from the stern. Large pieces of hull lie on top of each other as a result of leveling the wreckage using dynamite. Some pieces of hull are facing upward while some hull pieces have their inside facing upward.

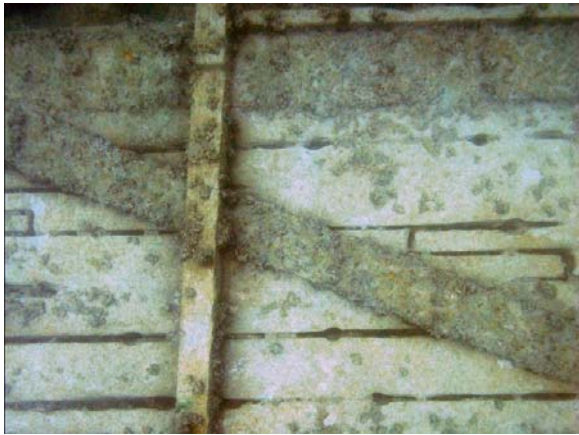
**Figure 20 - Diagonal Steel Bracing**

James Davidson made some of the largest wooden boats on the Lakes. He used steel plates to extend the practical length of wooden hulls. In effect, Davidson built a steel truss attached to the inside hull planking on either side. This steel bridgework minimized hull flexing common in wooden boats. This made building wooden hulls to 300+ ft possible. The truss was made with ½ in steel plate bolted to the inside of the hull planking with square headed bolts and nuts. The longitudinal plates were 18 in wide, while the plates running diagonally were 12 in wide. See the diagonal braces on No. 1 in Figure 16 and on No. 2 in Figure 20.

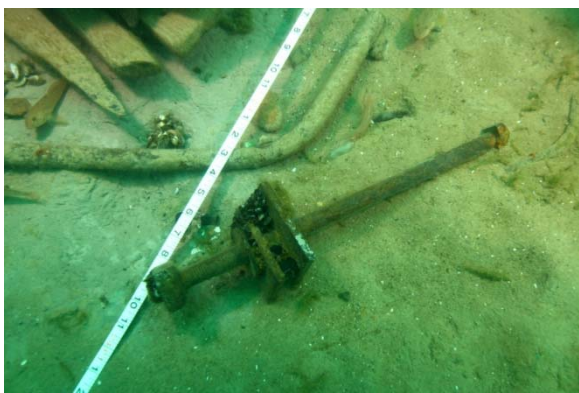
**Figure 22 - Steel Rod With Plates and Nut**

The deck beams are on 24 in centers and measure 10 to 12 in wide and are 12 in thick. A unique construction feature is the use of 1¾-in steel rod every 5 deck beams to hold the hull sides together in tension. A turnbuckle is employed in the center holding the two pieces of rod together. Perhaps these turnbuckles were occasionally tightened as the stress of the loaded railcars caused the deck to work loose from the hull.

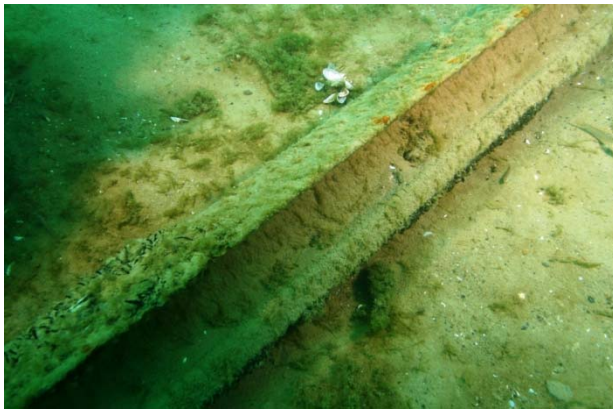
**Figure 25 - Typical Rail**

There are pieces of rail present in two areas of the wreck. The bow has several pieces of rail present among the scattered wood. The other area with rail is 32 ft forward of the stern and to the left of the centerline. A large number of deck beams are missing and much of the rail is twisted and bent, probably from the scuttling and explosion. Measurements and impressions were taken here and at the bow in attempt to find dimensional differences between the different weight rails; however no rail size variances could be detected among the rails measured. No brand, (rail size, mill plant, and date of rolling), was found on any rail found at the wreck site.

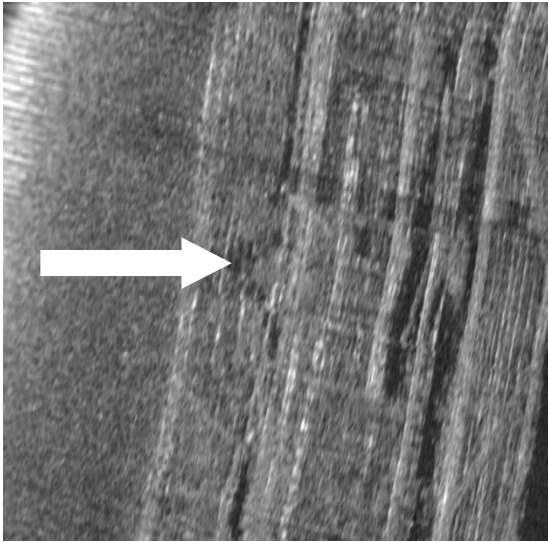
**Figure 41 - Anomaly Originally Discovered in a Sidescan Sonar Image.**

Another anomaly first discovered in the sidescan images is the hole shown in Figure 41 to Figure 43. Judging by the broken steel beam in the photo, this was not simple damage, but was more likely caused when a hole was blasted to sink it to the bottom of the lake, or later when it was further flattened to provide adequate clearance for passing ships.
