# **Project Report for the Avocational Archaeological Survey of the Railroad Car Ferry Number 2 (Indiana Site 12La0642)**

**Submitted in Partial Fulfillment of the Qualifications for NAS II Certification**

**Underwater Archaeological Society of Chicago**

**February 2016**

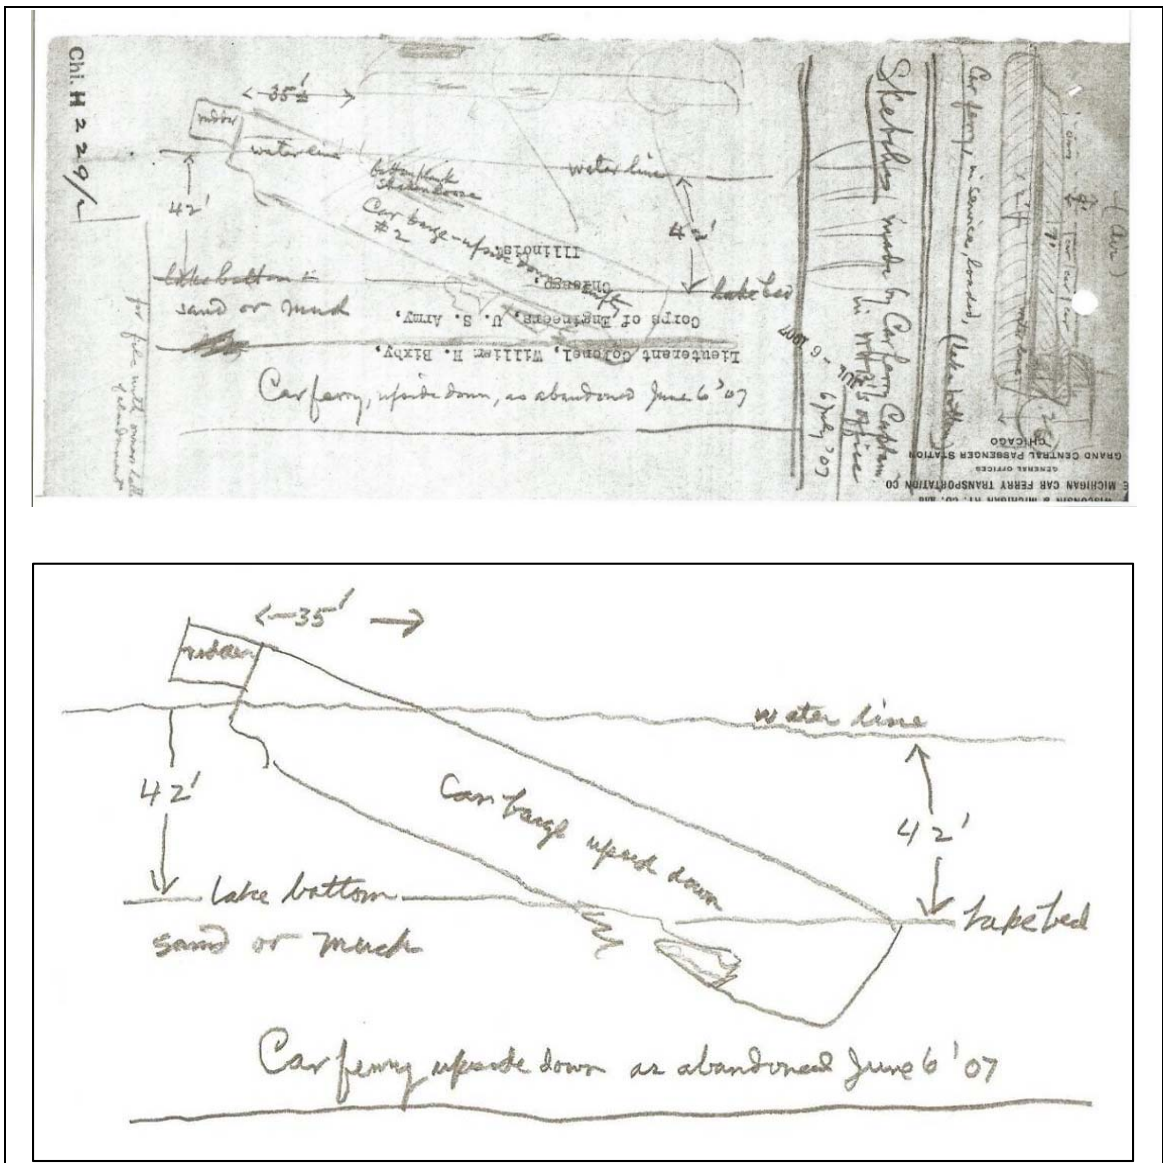
**Figure 3 - Hand Drawn Sketch of the Wreck from 1907 (above), and Cleaned Up (below).**

In the spring of 1907, the overturned hull of No. 2 Barge was towed out to a spot approximately 3.5 miles E/NE of the Calumet Harbor light. Attempts to turn over and right the hull were unsuccessful, resulting in the bow sinking. At this point, the stern was still floating, but the bow was stuck in the lake bottom, in approximately 42 feet of water, as shown in a sketch literally on the back of an envelope from 1907, as shown in Figure 3[10].

In August 1907, Great Lakes Dredge and Dock won and executed the contract to scuttle her where she lay, and remove the hull as a hazard to navigation. However, in the following year, a September 1908 report stated there was still less than 24-ft clearance over some parts of the wreck, and so she was dynamited as she lay on the bottom[10].

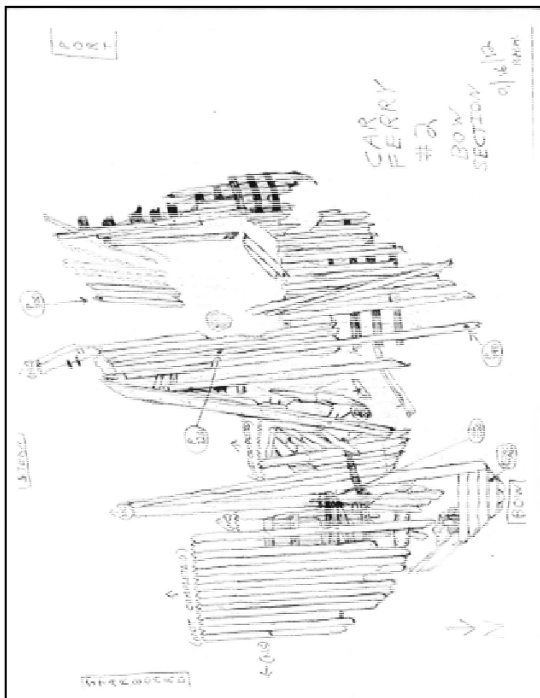
**Figure 17 - Bow Sketch by Robert Hughes.**

The main wreck site is quite large, measuring 330 ft long and as wide as 100 ft in parts. The centerline lies at 350 degrees with the bow at the north end. The bow area is broken and scattered, as shown in Figure 17 and Figure 18:

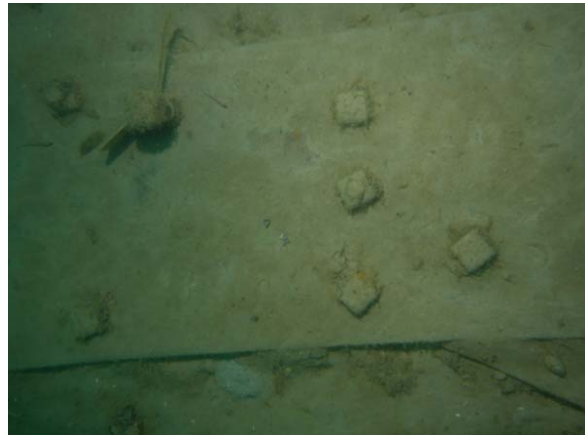
**Figure 21 - Steel Plate With Square Nuts**

James Davidson made some of the largest wooden boats on the Lakes. He used steel plates to extend the practical length of wooden hulls. In effect, Davidson built a steel truss attached to the inside hull planking on either side. This steel bridgework minimized hull flexing common in wooden boats. This made building wooden hulls to 300+ ft possible. The truss was made with ½ in steel plate bolted to the inside of the hull planking with square headed bolts and nuts. The longitudinal plates were 18 in wide, while the plates running diagonally were 12 in wide. See the diagonal braces on No. 1 in Figure 16 and on No. 2 in Figure 20.

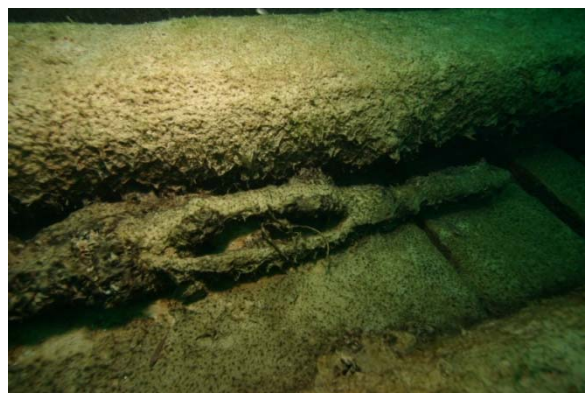
**Figure 23 - Turnbuckle**

The deck beams are on 24 in centers and measure 10 to 12 in wide and are 12 in thick. A unique construction feature is the use of 1¾-in steel rod every 5 deck beams to hold the hull sides together in tension. A turnbuckle is employed in the center holding the two pieces of rod together. Perhaps these turnbuckles were occasionally tightened as the stress of the loaded railcars caused the deck to work loose from the hull.

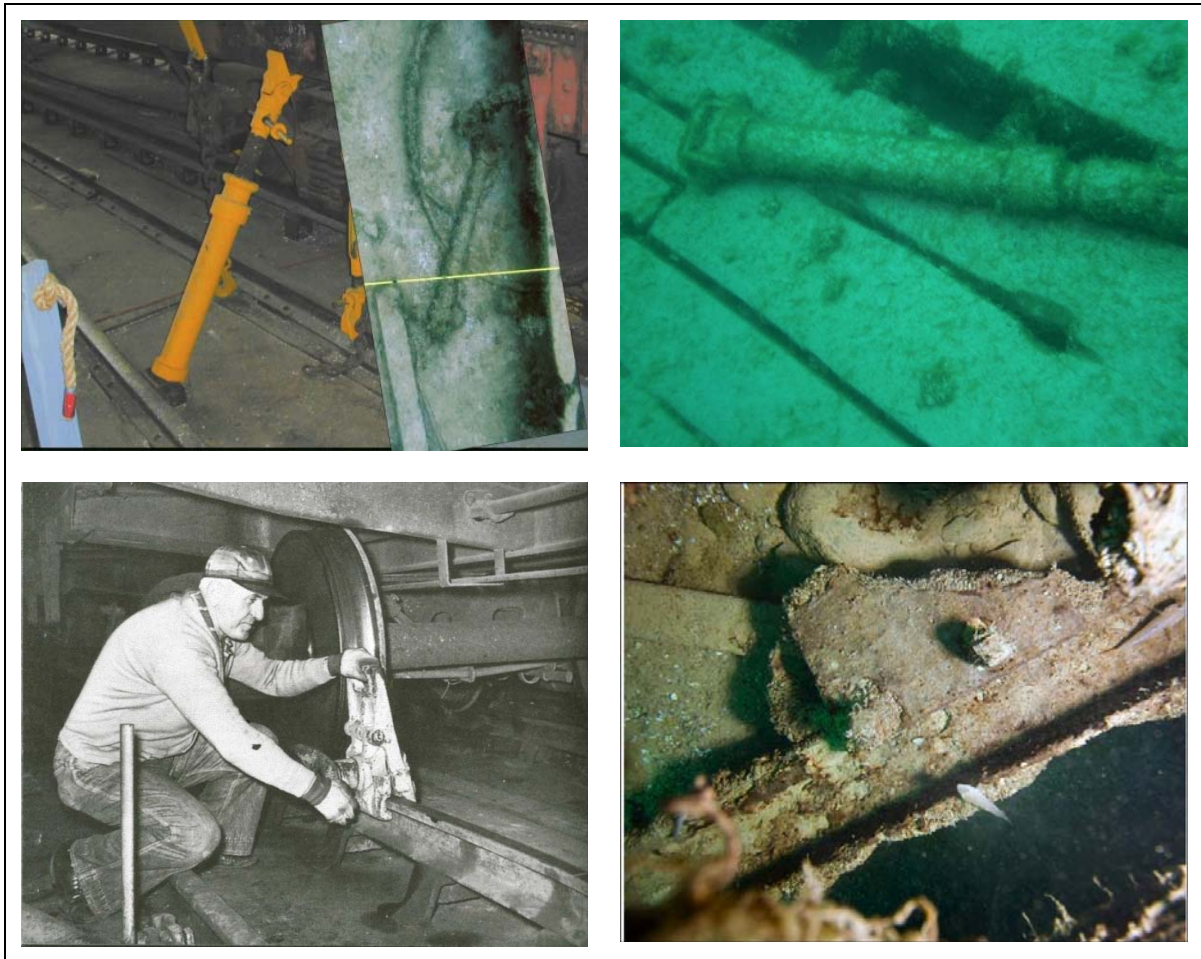
**Figure 24 - Screw Jacks and Rail Clamps, In Use and In Situ**

According to Hilton[3], two weights of rail were used on the No. 2 Barge. The railcars traveled on a 75-pound (lb) rail, while a lighter 60-lb rail was used outside of the car track. This lighter rail was called the jacking rail. A screw jack was positioned against this rail and used to slightly lift the car. A chain was then used to fasten the car to the jacking rail. The combination of upward force from the screw jack and downward force from the clamped chain provided stability and secured the railcar to the deck. Wheel chocks were also clamped to the 75-lb rail to prevent movement during rough seas, and hand brakes set on each car, as per standard industry practice.

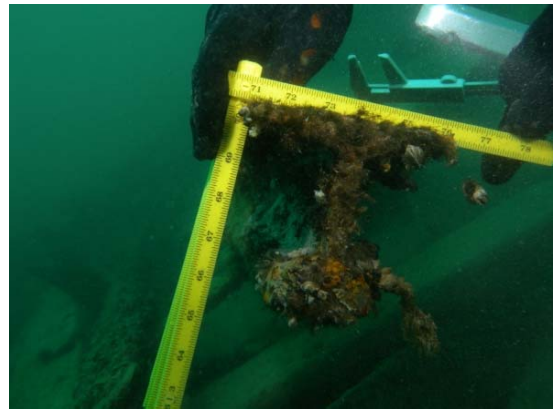
**Figure 26 - Measuring Rail Dimensions**

There are pieces of rail present in two areas of the wreck. The bow has several pieces of rail present among the scattered wood. The other area with rail is 32 ft forward of the stern and to the left of the centerline. A large number of deck beams are missing and much of the rail is twisted and bent, probably from the scuttling and explosion. Measurements and impressions were taken here and at the bow in attempt to find dimensional differences between the different weight rails; however no rail size variances could be detected among the rails measured. No brand, (rail size, mill plant, and date of rolling), was found on any rail found at the wreck site.

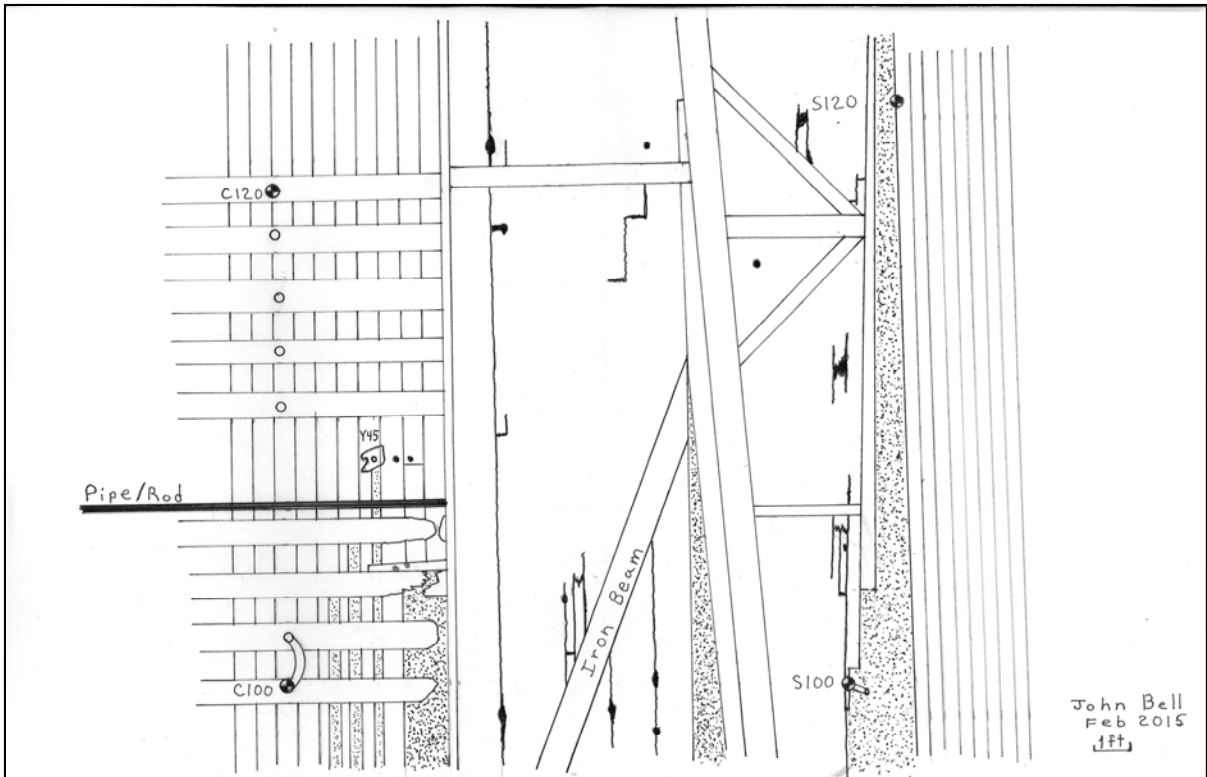
**Figure 37 - Final Drawing of Section C100-S120, Based on Two Dives**

The third diver, John Bell, created the intermediary drawing shown in Figure 35 based on his original set of notes, and then took that drawing on Mylar on a second dive to the same section. On that return visit he took additional notes and GoPro video as shown in Figure 36, and used the additional information to produce the final drawing shown in Figure 37.

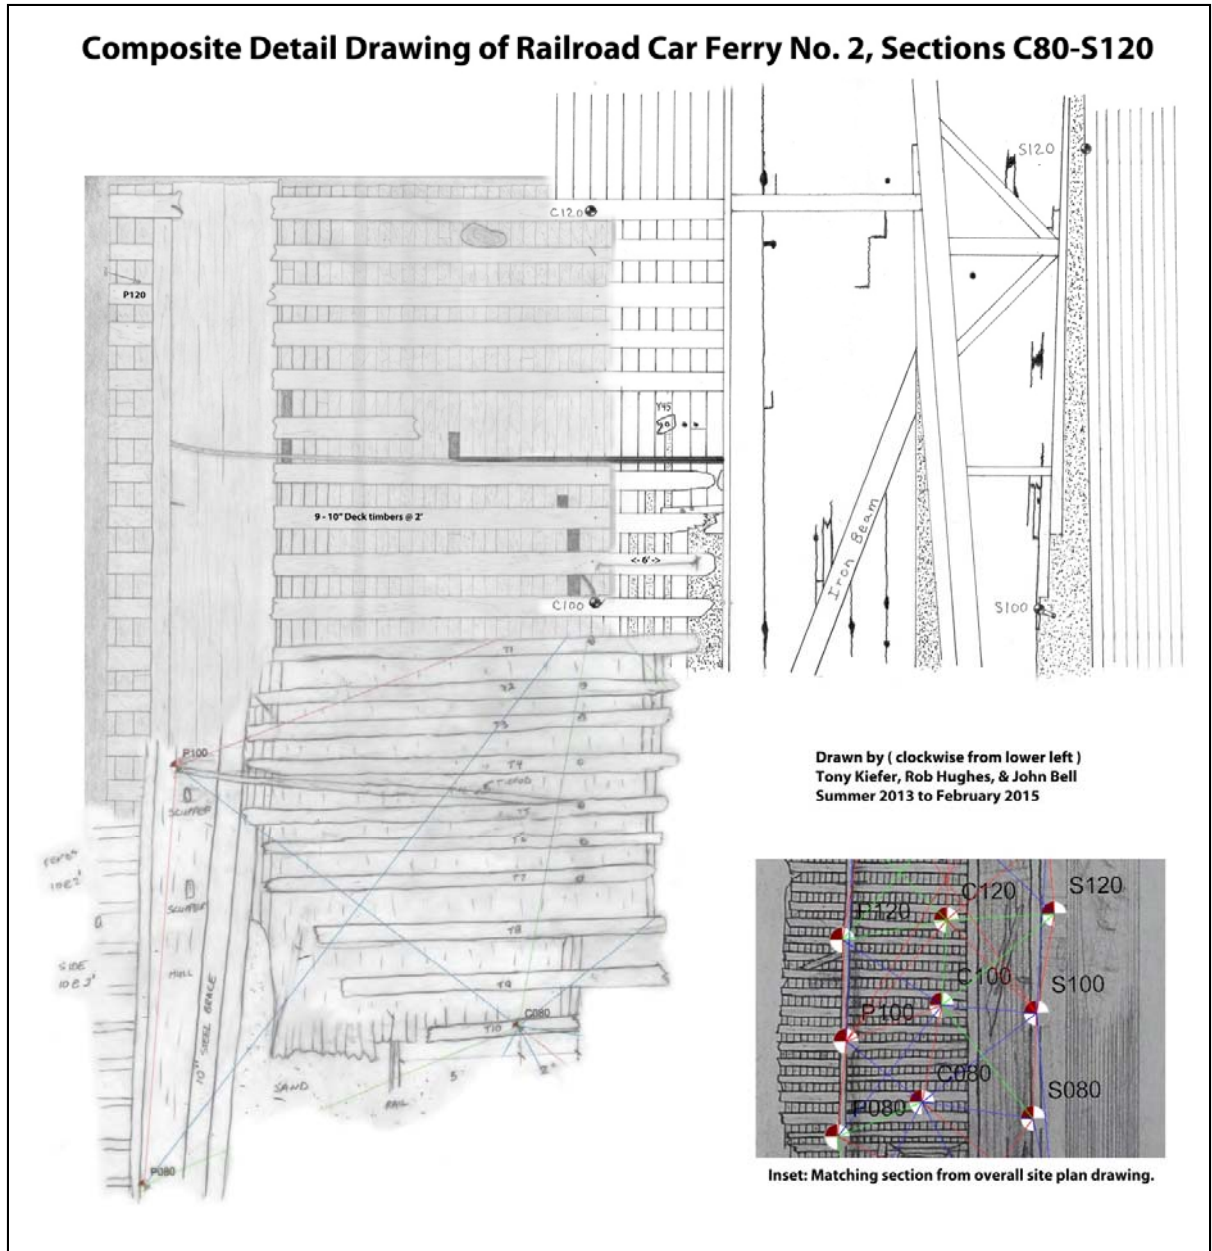
**Figure 38 - Composite of Three Final Drawings, Covering P80 - S120, with Inset**

By aligning the common reference tags between the three completed detailed drawings, the composite shown in Figure 38 was produced, with very little effort.

Thanks to the reference tag grid system, there was no difficulty lining up the three sketches exactly, even though the three divers had very different styles, and in one case a different scale. This shows how valuable the reference tag system was for combining and integrating results from different surveyors, and opens the door for more than 30 future detailed site studies. This also shows how any diver of any ability or experience, (e.g. any beginning underwater archaeology student), can contribute to the project and have their contribution added to the growing detailed site plan.

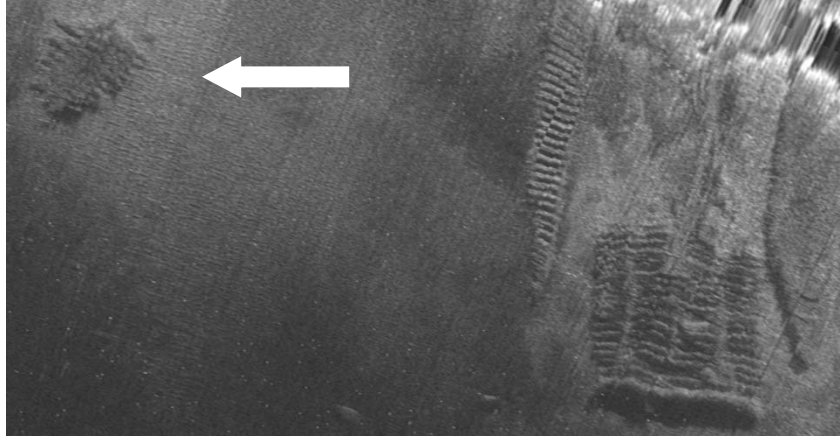
**Figure 39 - Sidescan Image Revealing an Outlying Piece, Approximately 50' WNW of the Stern.**

While conducting the sidescan sonar survey discussed above, an extra piece of the wreckage was discovered as shown in Figure 39, affectionately named "The Western Chunk." Surveyors Robert Hughes and Julie Scheibe produced the sketch shown in Figure 40, and later a line was attached between the chunk and the main wreck site, to aid future divers and surveyors in finding the chunk and returning to the main site safely.

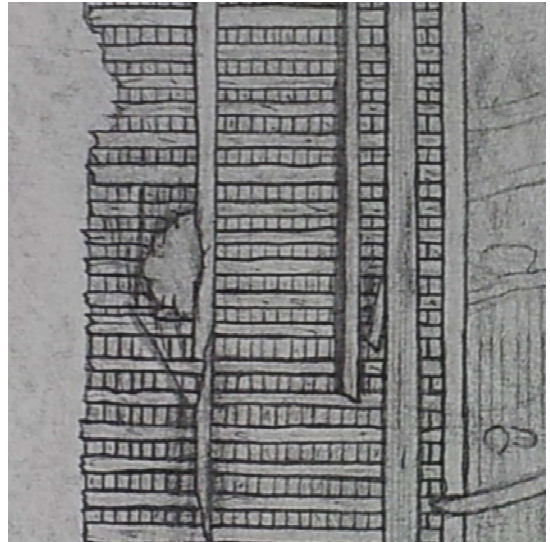
**Figure 42 - Anomaly Shown in Site Plan Drawing.**

Another anomaly first discovered in the sidescan images is the hole shown in Figure 41 to Figure 43. Judging by the broken steel beam in the photo, this was not simple damage, but was more likely caused when a hole was blasted to sink it to the bottom of the lake, or later when it was further flattened to provide adequate clearance for passing ships.
